LOWER HUDSON RIVER BASIN

NEW CENTRAL PARK
RECEIVING RESERVOIR
NEW YORK COUNTY NEW YORK
INVENTORY NO 188

PHASE I INSPECTION REPORT
NATIONAL DAM SAFETY PROGRAM

JULY 1978

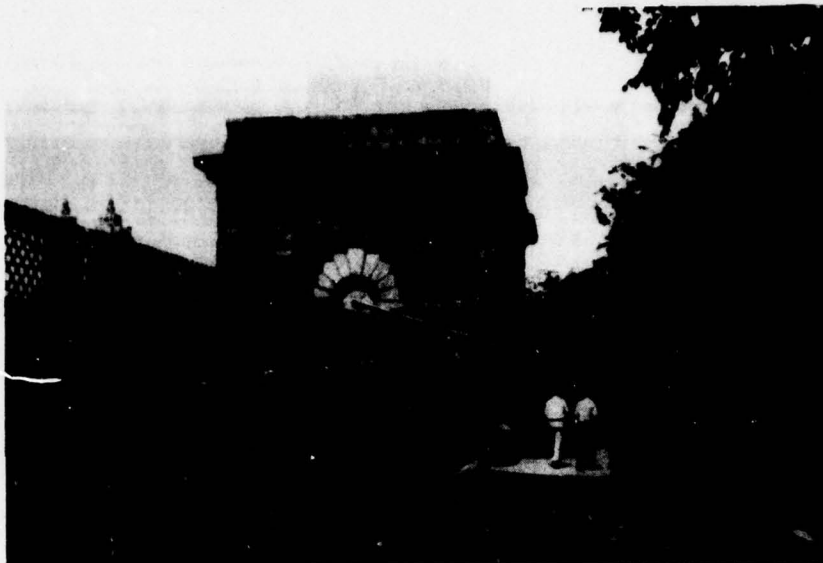
3. View along reservoir path at location of intake structure.

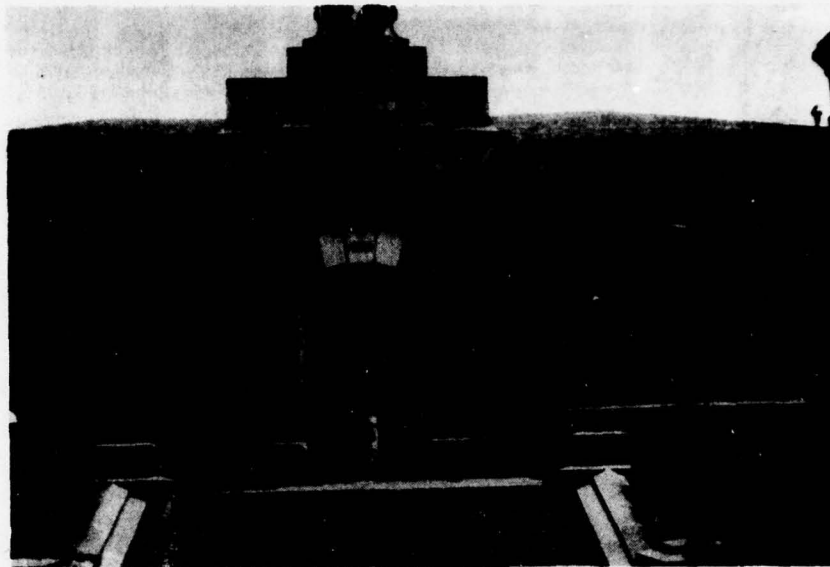
5. Picture of south downtake structure and control center.
